Investigation into the Ashland Oil Storage Tank Collapse on January 2, 1988

NBSIR 88-3792

**John L. Gross
Felix Y. Yokel
Richard N. Wright
A. Hunter Fanney**

Issued June 1988

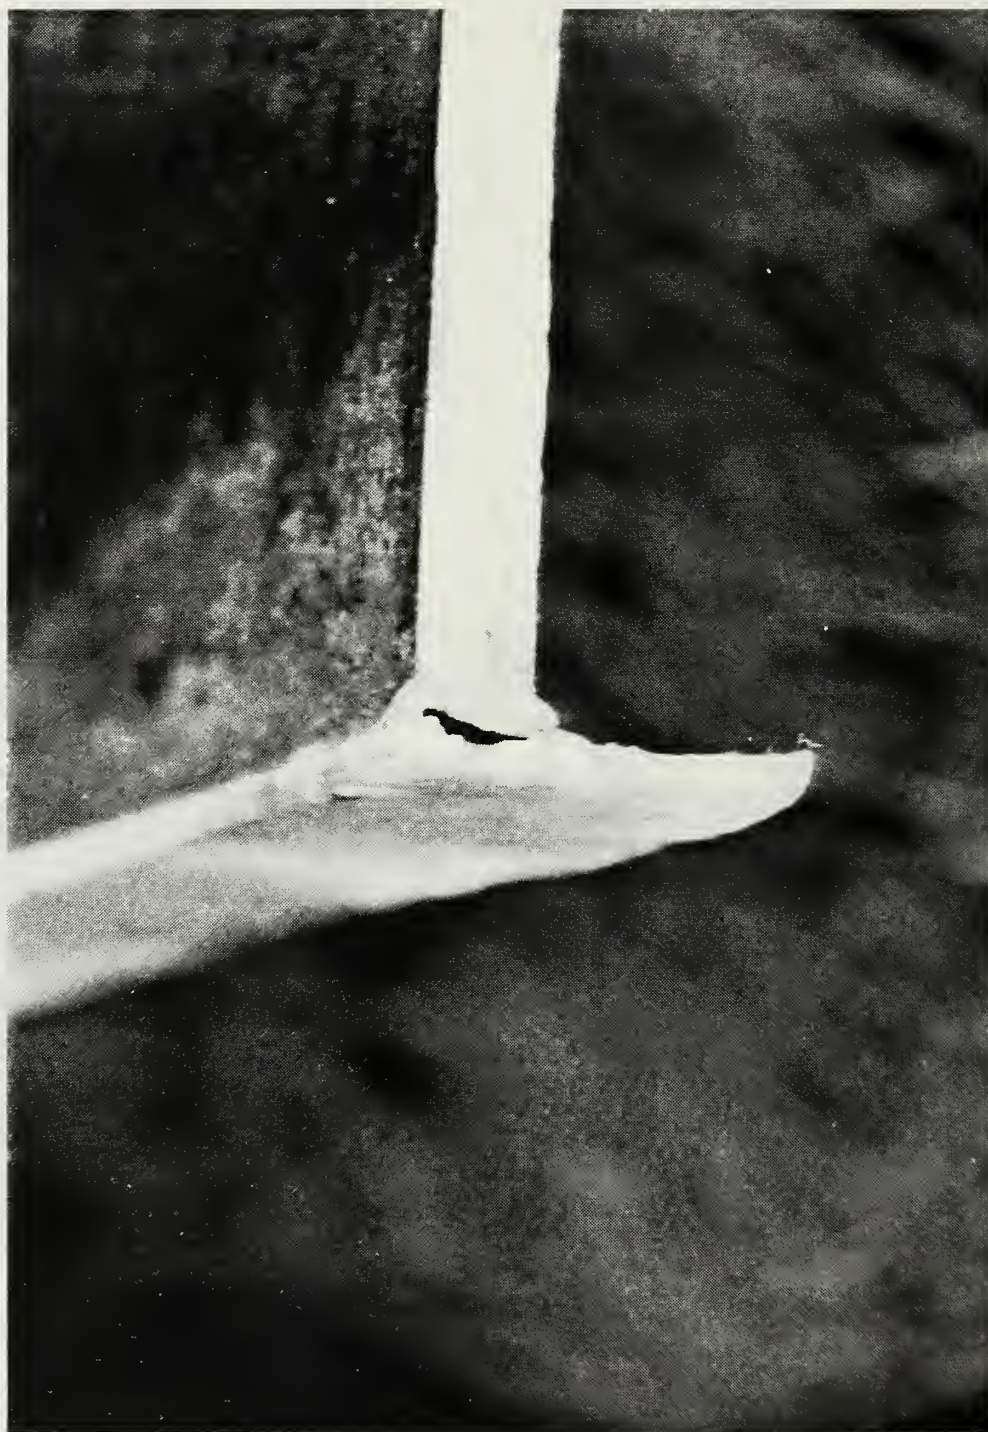
Figure 3.6 - Tear in Tank Bottom at Inside Fillet Attaching First Shell Course and Bottom Plate

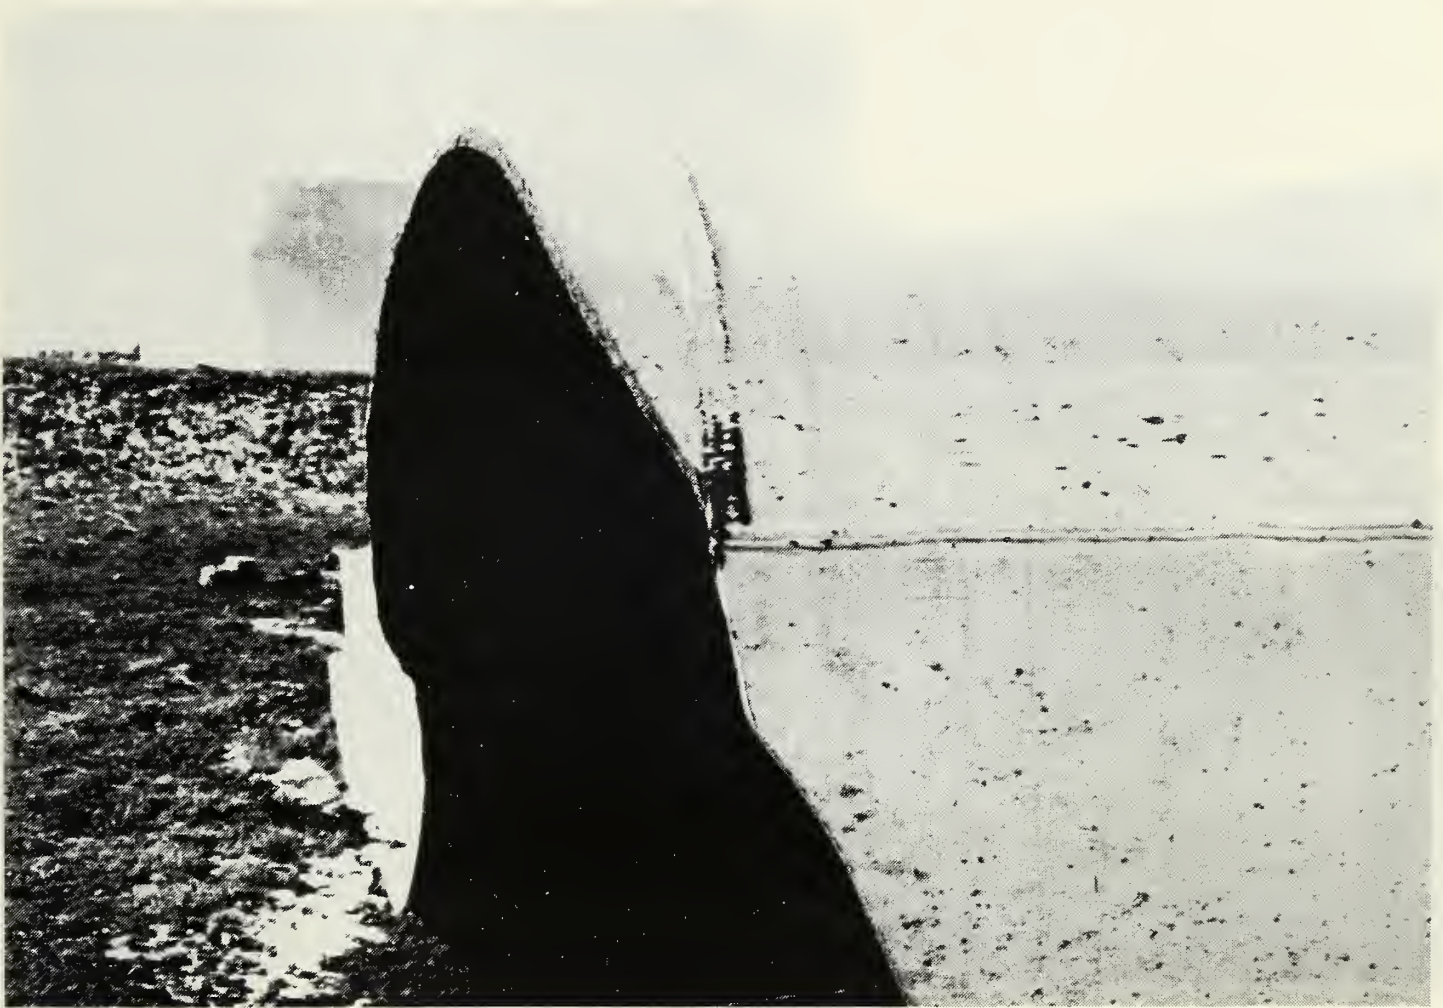
Figure 3.9 - Right Side of Fracture

One side of the fracture in the tank wall came to rest inside the dike area near Tank No. 1366. It is shown in Figure 3.9. The fracture surface was flat and perpendicular to the tank wall indicating that it was a brittle fracture. Chevrons were evident on the fracture surface (see Figure 3.10). The chevrons pointed to a dark area extending about two-thirds of the way through the plate thickness (see Figure 3.11). The location of this dark area is just below the horizontal weld, between the first and second shell courses, and just to the left (looking from the outside of the tank) of a vertical seam in the second course. The fracture was believed to have initiated at this point and extended to the top and bottom of the tank wall. A diagram showing the path of the fracture is shown in Figure 3.12. Note that the fracture neither started nor propagated in the welds.

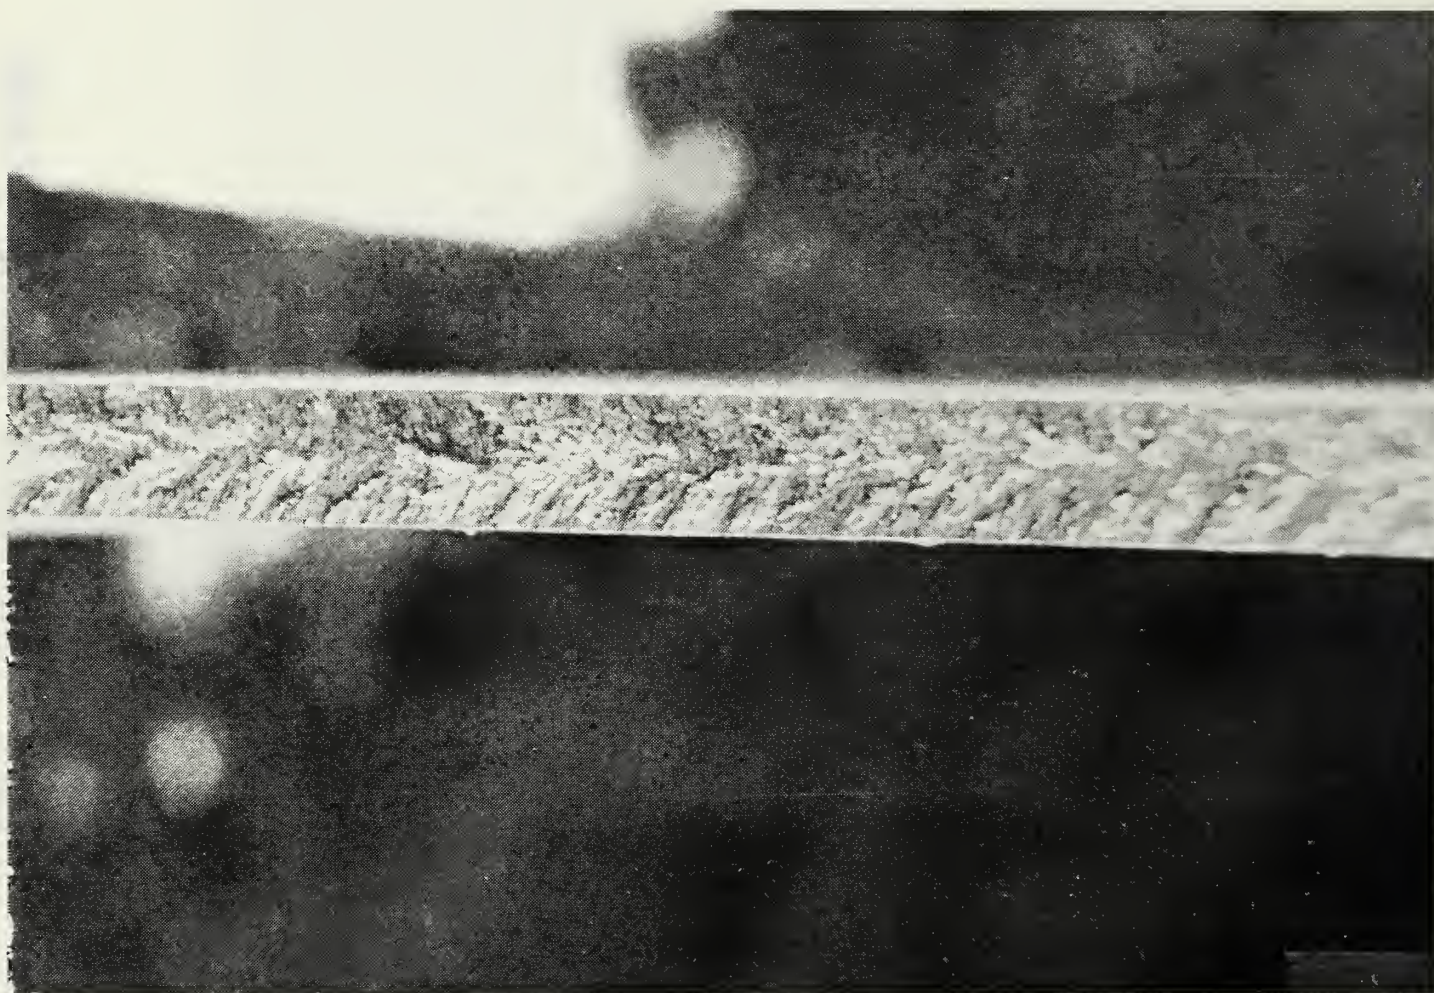
Figure 3.10 - Chevrons in Fracture Surface

The flat surface of the fracture of the shell indicated that it was a result of brittle fracture. Chevron-like markings were evident on the fracture surface. These pointed to a flaw extending about two-thirds of the way through the plate thickness and located about 8 ft above the base of the tank, just below the horizontal weld between the first and second shell courses, and just to the left (looking from the outside of the tank) of a vertical seam in the second course. The chevron markings, pointing to the flaw from above and below, are convincing evidence that the fracture of the shell initiated at this flaw.

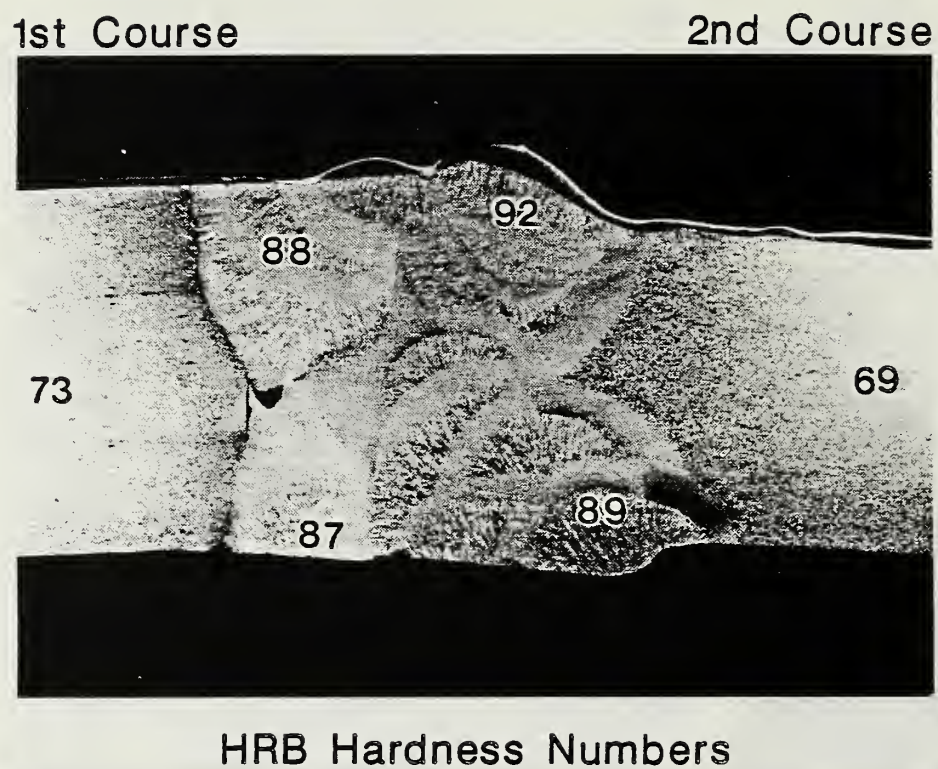
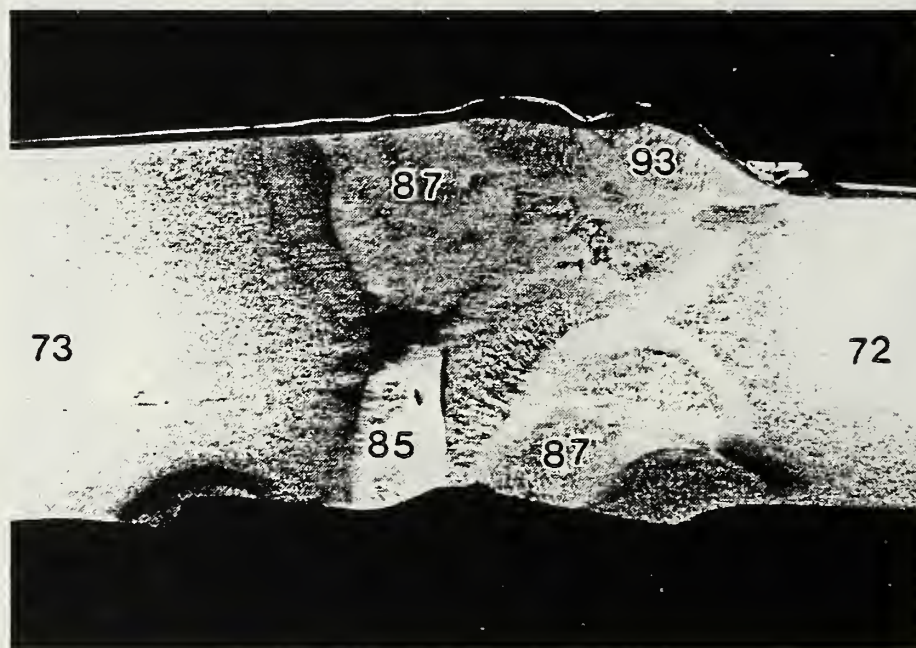
Although the weld quality did not conform to API 650, the weld quality was not a contributing factor in the initiation or propagation of this fracture. However, welding adjacent to the flaw contributed to embrittlement of the metal.

Figure 7.18 - Defects in Horizontal Weld Metal

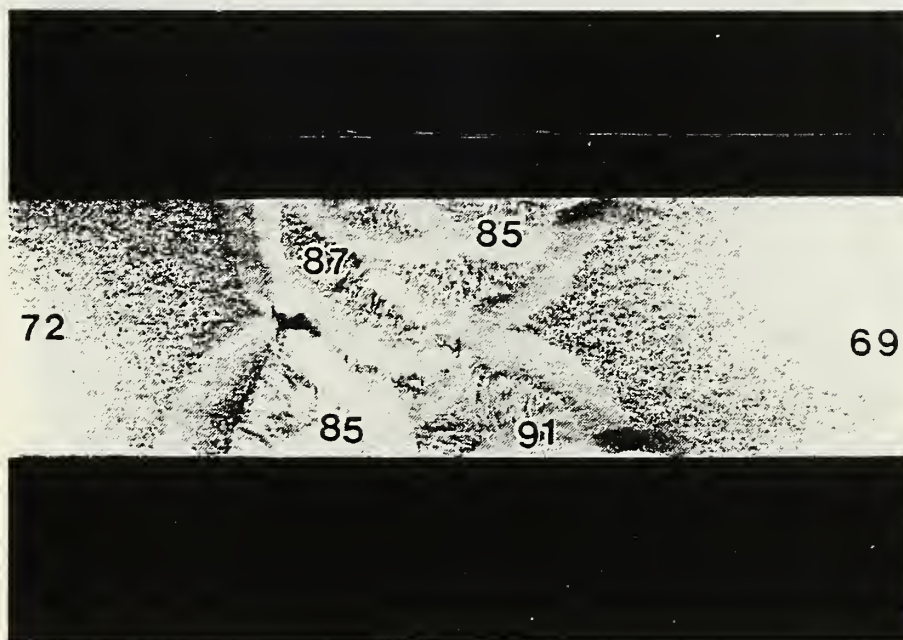
Figure 7.19 - Defects in Horizontal Weld Metal
after Grinding Welds

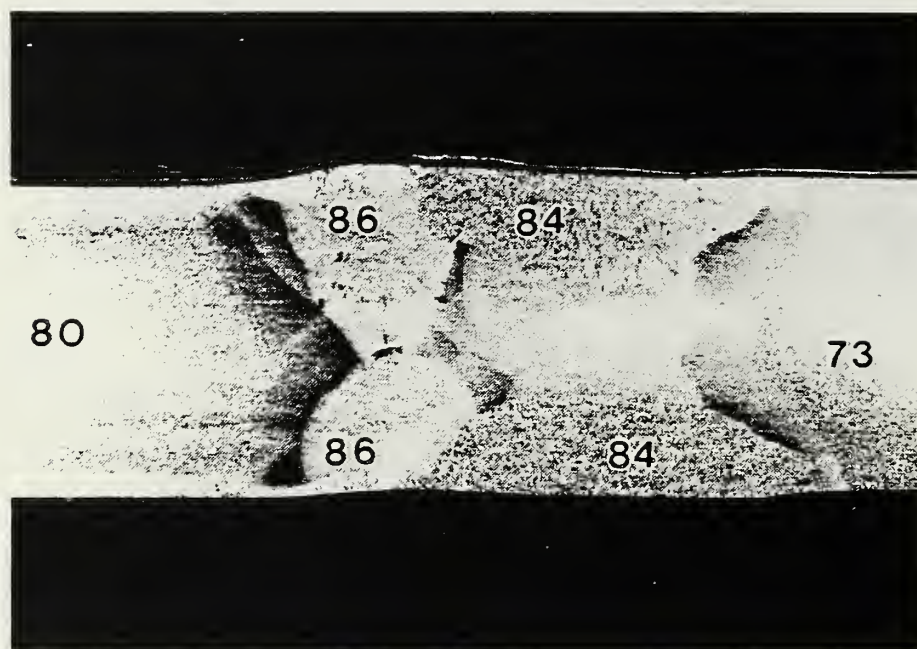
Figure 7.20 - Defects in Vertical Weld Metal

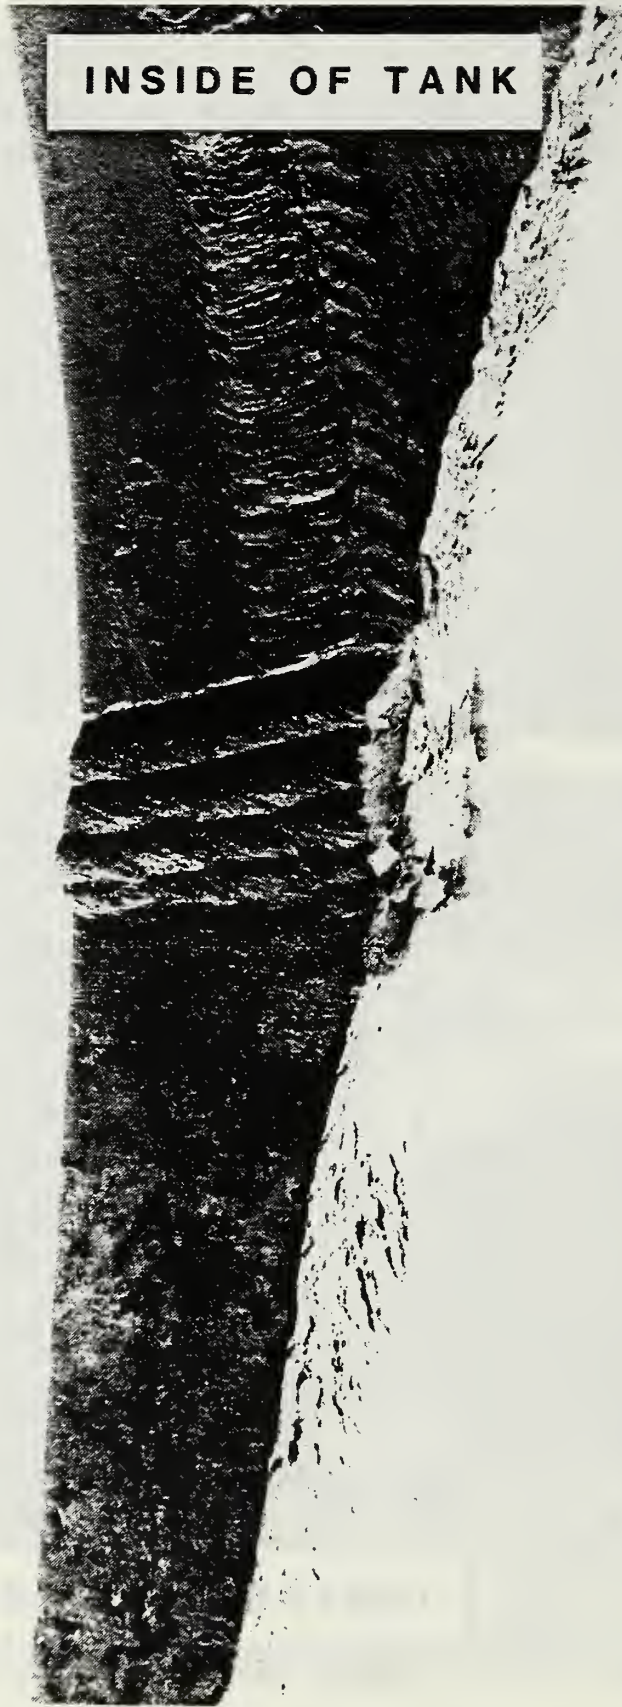
The failure of the tank was caused by a brittle fracture that initiated at a flaw in the tank shell about 8 ft above the base and just below the horizontal weld between the first and second courses of steel. The fracture propagated to complete rupture of the tank shell because the steel lacked sufficient toughness to arrest a propagating fracture at the temperature and stresses existing in the tank shell.

Figure 7.22 - Fracture Surface Defect

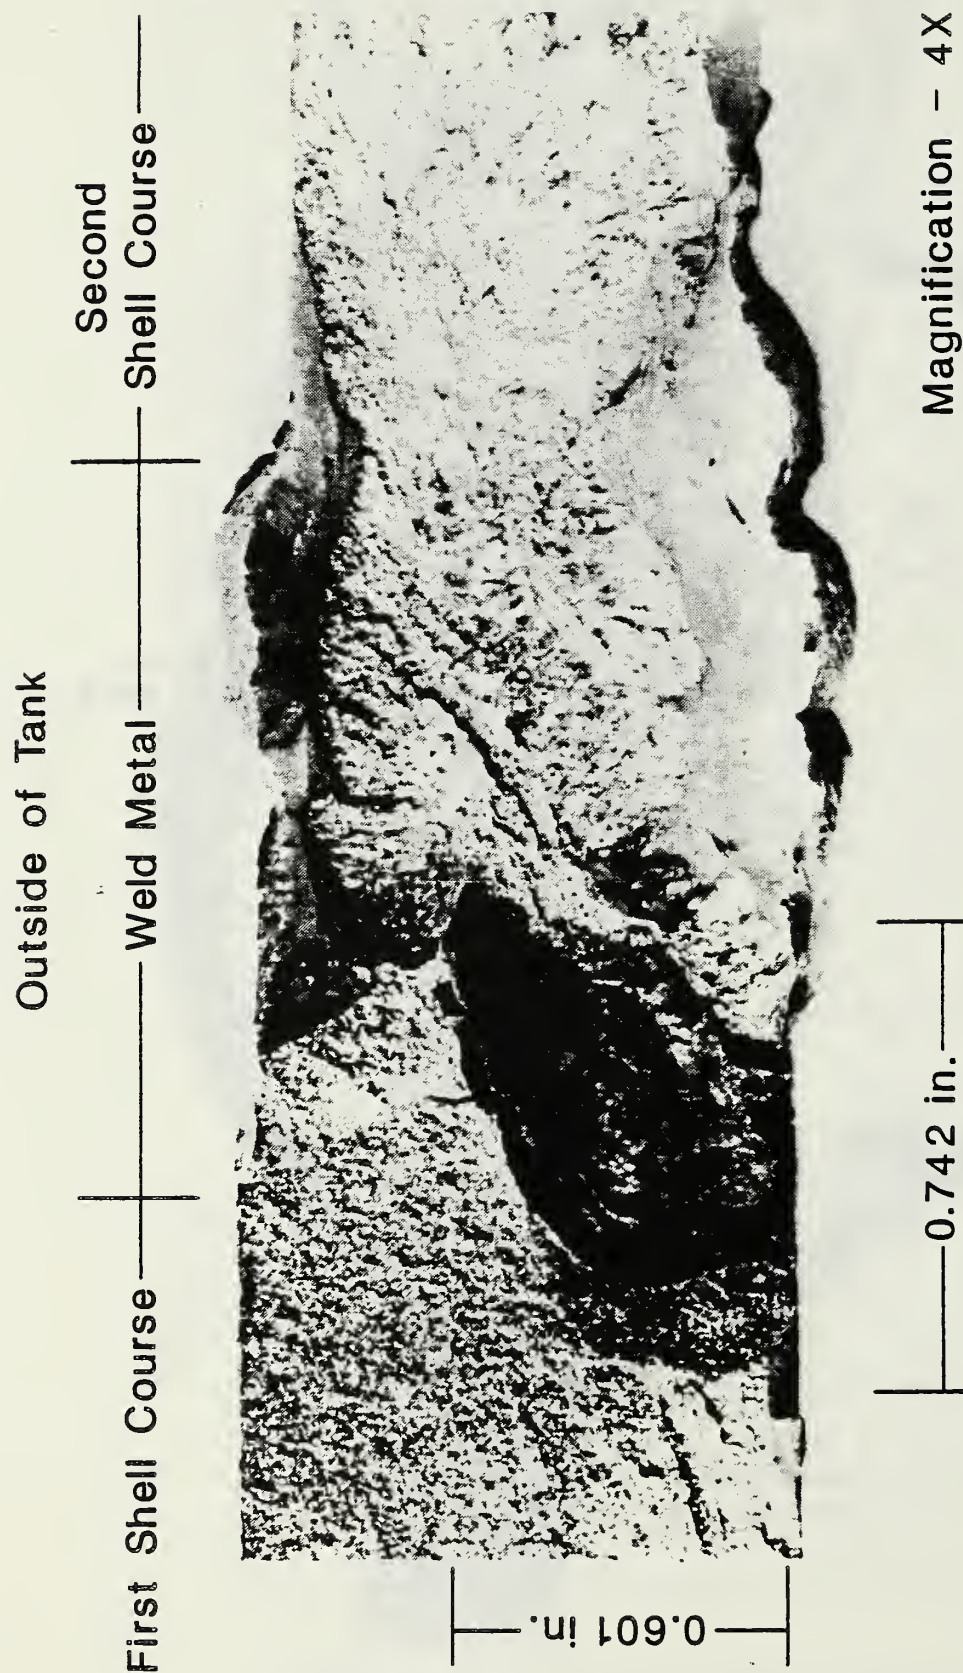
Figure 7.24 - Defect on Fracture Surface

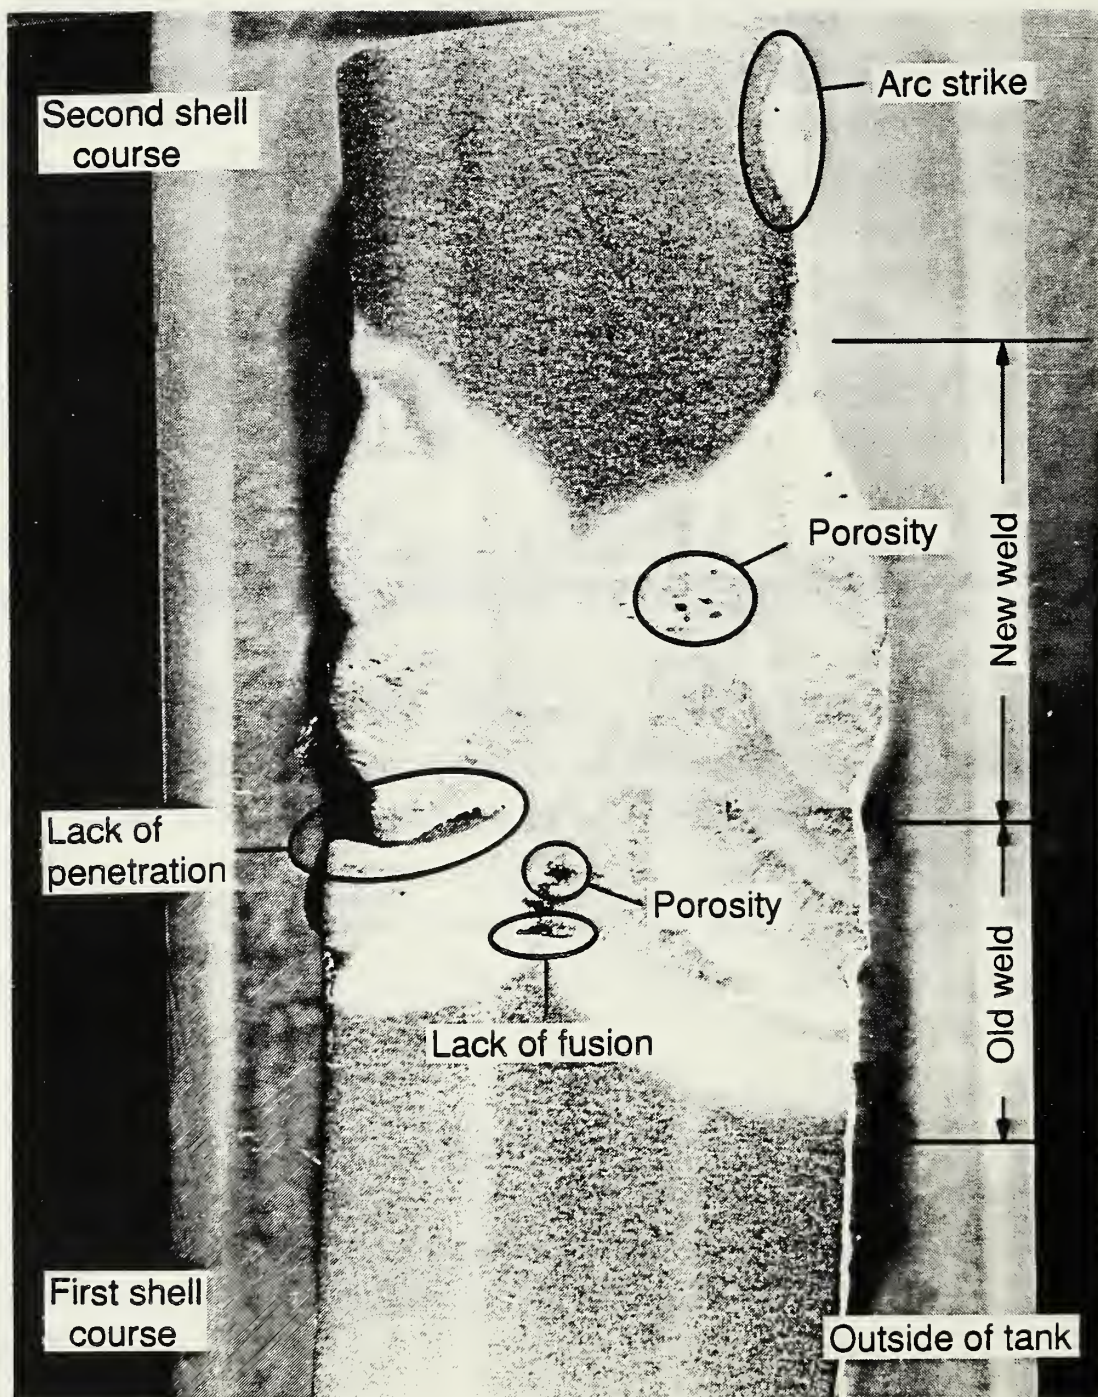
Figure 9.1 - Defects in a Horizontal Weld between the First and Second Shell Courses
